Sabine River Basin Summary Report 2018

Prepared in Cooperation with the Texas Commission on Environmental Quality
The preparation of this report was financed in part through funding from the Texas Commission on Environmental Quality.

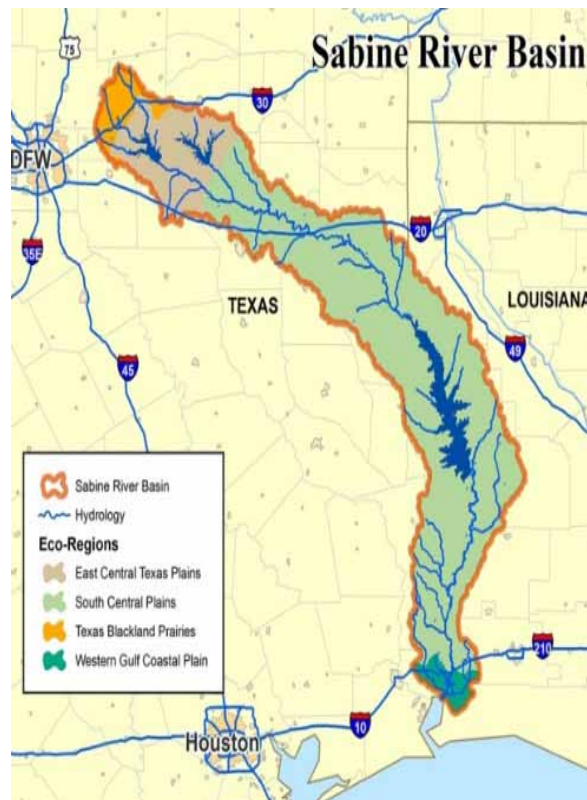
Figure 1. Sabine River Basin

The Sabine Basin (Figure 1) is roughly crescent-shaped, with a length of approximately 300 miles and a maximum width of approximately 48 miles. The Sabine River is approximately 580 river miles long from the basin divide in Hunt County near the City of Celeste, to its mouth at Sabine Lake. The watershed area in Texas includes all or part of twenty-one counties. It extends southeasterly for 165 miles from its source in Hunt County to the headwaters of Toledo Bend Reservoir at the Texas-Louisiana border. At the point where it becomes the state line, the Sabine River drains an area of approximately 4,846 square miles. The State of Texas has jurisdiction to the midstream boundary for the state line reach of the Sabine River, of which approximately 2,550 square miles lie within Texas and 2,360 square miles lie within Louisiana. The Texas portion of the watershed makes up approximately 76 percent of the total area of the basin.
