Sabine River Basin Big Cow Creek Watershed Characterization Report 2020

Sabine River Authority of Texas
P.O. Box 579
Orange, TX 77631
Phone (409) 746-2192

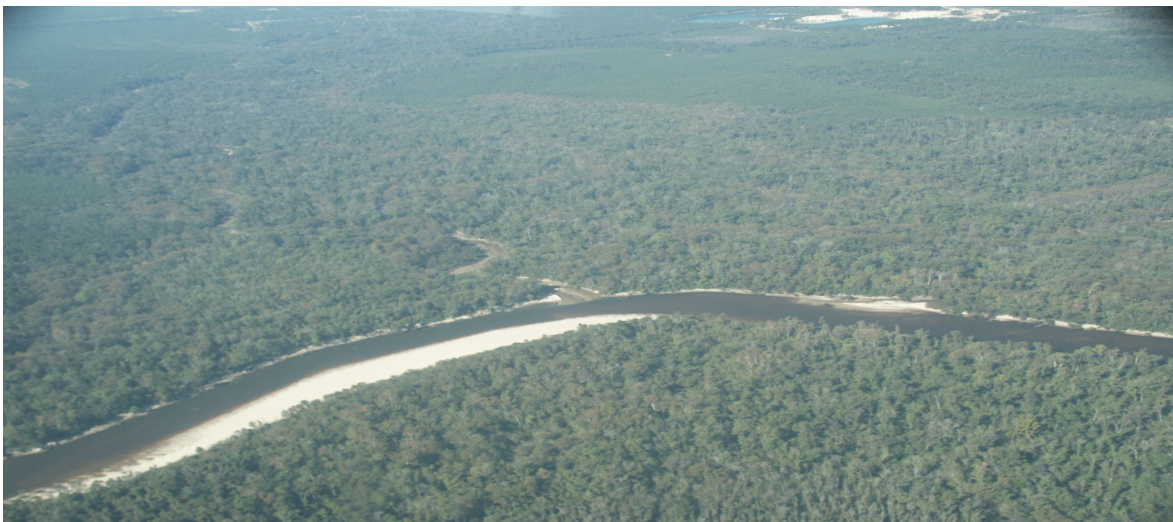
Figure 1. Big Cow Creek Watershed Segment 0513

Segment 0513 (see Figure 1) begins from the confluence with the Sabine River in Newton County to a point 4.6 kilometers (2.9 miles) upstream of R 255 in Newton County. The BCC watershed is 37 miles long, 15 miles wide, has an approximate drainage area of 349 square miles and is in the Western Gulf Plain Ecoregion. The upper watershed is characterized by rolling sand hills, open mixed forests, and scattered pine groves. The lower section is bottomland composed of mixed hardwood and pine. The watershed covers parts of Jasper and Newton counties and is largely rural with no major industries.

BCC is comprised of two assessment units (AUs): AU0513_01 and AU 0513_02. AU 0513_01 is defined as BCC from the confluence with the Sabine River southeast of Kirbyville upstream to the confluence of White Oak Creek east of Kirbyville (Figure 1). AU 0513_02 is defined as BCC from the confluence of White Oak Creek east of Kirbyville to the headwaters 4.6 kilometers (2.9 miles) upstream of Recreational Road 255 in Newton County (Figure 1). The City of Kirbyville has a population of 2,142 (US Census Bureau, 2010) and is located in the Trout Creek watershed, a tributary to BCC (see Figure 1). The TCEQ station ID used for the 2020 IR assessment along with its description, assigned AU ID and monitoring entity are listed in Table 1.

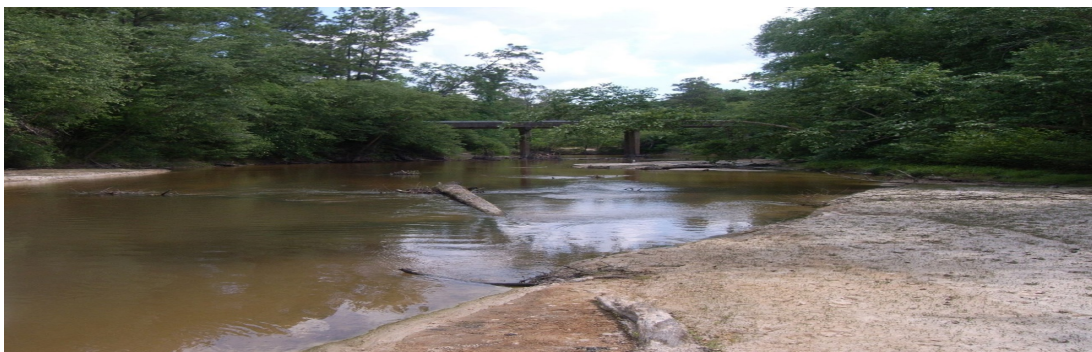
Figure 2. Big Cow Creek Watershed Land Cover Classification Segment 0513

Spatial analysis of this segment indicates that evergreen forests, woody wetlands, and shrub/scrub accounts for 79 percent of land use (see Figure 2). Herbaceous, mixed forest, hay/pasture and developed open space account for an additional 14 percent of land use. Low intensity development is 1 percent, with medium and high development less than 1 percent each. Small family livestock farming and silviculture activities occur within this rural watershed. The watershed population is approximately 8,400, which correlates to a density of 24 people per square mile (US Census Bureau, 2010).
